Injury during maintenance work on a Parker Jaw Crusher 1165 Rockranger

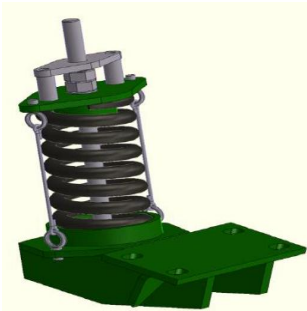
The draw bar was being undone when the studs failed and the top part of the stud and bolt ejected giving a glancing blow to the operator's head and hitting his safety helmet. Fortunately, the operator was not seriously injured.

The exact reason for the failure is not known but the stud has been sent away for analysis. The springs may have been either fully or over compressed (bottoming out), which may have stressed the studs.

Image shows restraining bars

- New springs have been fabricated with less turns, thus reducing the pressure applied and reducing the chances of the spring bottoming out if an item gets stuck in the jaws
- New draw bars will be fitted on all major overhauls
- New draw back guards, with restraining bars fitted to the top collars to prevent a recurrence.
