Incident involving the transport of dump trucks 50 tonnes and over

ALERT STATUS: Normal
DATE ISSUED: 05/12/2016 16:05:27
INCIDENT No: 01444

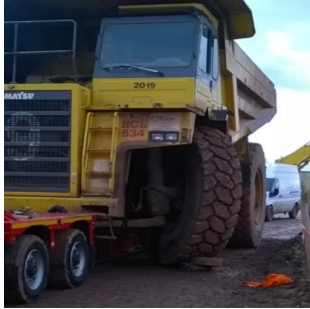
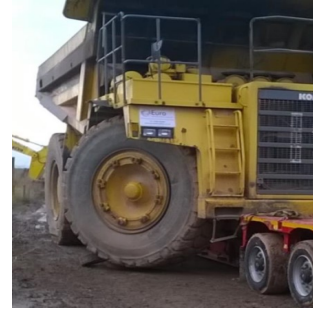
On assessing the site, it appears that the wheels had turned from parallel to the vehicle sides to their final resting position, by the offside rolling forward off the block on which it was elevated; and the near side rolling backwards.

What is not clear, is what caused this movement, from what had been a stable position for some time; to slow initial movement and then quicker in its final moments. The fact that the nearside tyre was not inflated to the same level as the off side one and the vehicle had not run for some time may have been contributing factors.

- The fact that the wheel moved while on the single sleeper, suggests this is not the ultimate solution as without the excavator bucket in place, the forces involved could move the sleeper
- What was required is something that physically stopped the wheels from pivoting.

Although not conclusive, it was felt that the extra length of the railway sleeper would offer some additional protection and this method was used, with the excavator bucket braced against the wheel to prevent any pivot movement, when carrying out the final tightening process to this DT.

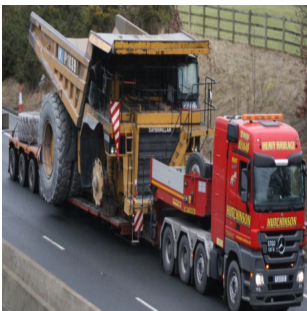
This DT was collected on a beam trailer, without the mattress boards on either side being installed, which gave the space for the wheel to pivot.

By installing these mattress boards, the width across the trailer is increased, limiting the space for movement of the wheel if this were to pivot. The use of low loader trailers would have a similar limiting effect, protecting anyone working in the wheel arches from being trapped.
