Fatal 6 - Ship's crew struck by falling hose

LOCATION: AGGREGATE DREDGER
ACTIVITY: CONTRACTOR SAFETY MANAGEMENT
SUB ACTIVITY: MARINE

ALERT STATUS: Normal
DATE ISSUED: 17/12/2019 17:04:16
INCIDENT No: 01541

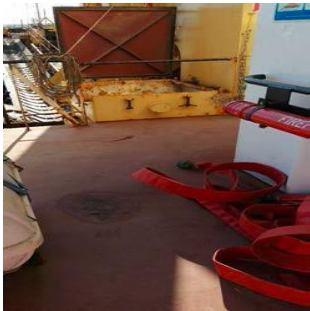
A UK marine aggregate dredger was in the final stages of a refit at a UK shipyard. During the refit, the ship had been supplied with fresh water through a shipyard hose. Shipyard workers were recovering the hose after it had been disconnected by a crew member, who had connected two sections of hose together.

Site of hose recovery

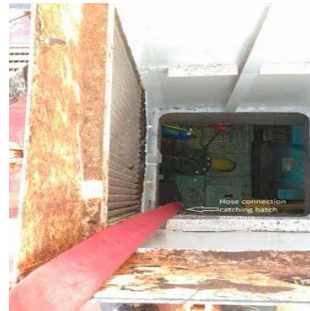
As the hose was hauled up by hand through a hatch, the bayonet connection between the two hose sections caught on the coaming; resulting in the two sections separating. The lower section dropped through the hatch; and, despite a shouted warning, struck the crew member on the forehead; requiring hospital attendance to close the wound.

- Beyond disconnecting the hose, crew members were assisting shipyard staff with a task, with which they did not need assistance
- Interaction between ship and shore personnel was not planned, assessed or coordinated
- The crew member failed to properly connect the hose sections together
- Whilst medical treatment was provided to the IP, the opportunity to preserve the scene and secure evidence was lost
- Adequate PPE was not being worn.

Hatch through which hose was being recovered

- Interaction between crew and contractors must be planned; to properly understand the task and apply necessary control measures.
- An appropriate level of assessment must be used for all tasks; including those perceived as low risk or minor.
- First-Aid/ medical treatment must be provided; however, duties must be assigned to ensure an incident scene is preserved; and evidence secured for investigation.
- Compliance with prescribed PPE requirements is mandatory; requirements must be clear to employees and not subject to interpretation.
