'The Fatal 6' - Struck by Moving/Falling Object - Falling Tool

CEMENT PLANT
MAINTENANCE & HOUSEKEEPING
N/A

ALERT STATUS: Normal
DATE ISSUED: 11/02/2020 10:41:45
INCIDENT No: 01548

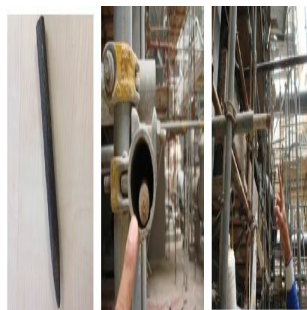
Tool & Location

During a dismantling of some fixed scaffolding by the onsite scaffolding contractor, a tool from a Jack hammer fell from the open end of scaffolding tube several meters to the ground below. It became apparent a third party contractor had previously placed the tool inside the horizontal scaffolding tube for storage.

The investigation is ongoing however it became apparent this is not a standalone incident and although this was raised several years ago with controls for elimination, the incident has occurred at least once previously. A full review of controls is being completed.

- Safety concern communicated to contractors.
- A TBT generated as a means of informing all future scaffolding activities.
