'The Fatal 6' - Unsafe Work at Height & Isolation Breach

ALERT STATUS: High Potential
DATE ISSUED: 03/04/2020 16:35:57
INCIDENT No: 02554

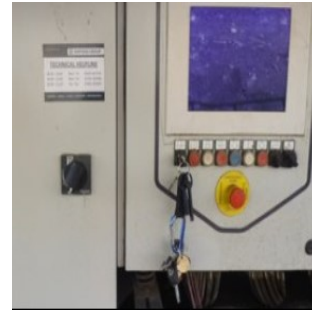
Contractors were observed working unsafely on a mobile crusher - the crusher wasn't fully isolated as per Company procedures and their transport vehicle was left unattended with the engine running.

- Unauthorised maintenance was being carried out by the contractor

- Equipment was not fully isolated by the contractor and the contractor did not contact any Company employee regarding the need for isolation

- Work at height was not controlled adequately or an authorised activity by the contractor

- All contractors must have a specified Company person who will be their point of contact
- The Company person must carry out and document regular interactions with the contractors whilst on site to ensure task-specific controls are in place and being followed
- All equipment before being worked on must have a Company isolation owner
- All working at height must be adequately controlled through robust HIRA (Hazard Identification & Risk Assessment) and Methods of Work
- All work carried out by contractors must be authorised by Company management.
