Near Miss - Falling Object

LOCATION: ASPHALT/COATING PLANT
ACTIVITY: MAINTENANCE & HOUSEKEEPING
SUB ACTIVITY: N/A

ALERT STATUS: Normal
DATE ISSUED: 12/08/2020 10:46:56
INCIDENT No: 02566

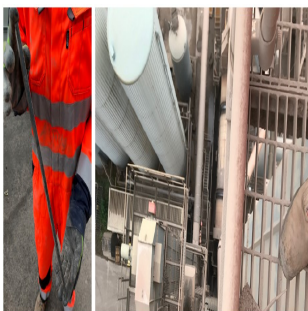
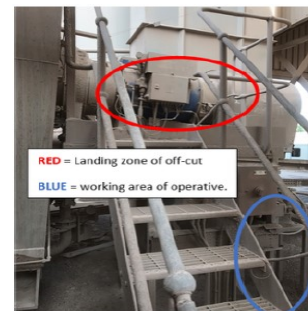
When the Fitter came to adjust the plate a sliver of metal fell through an open mesh and landed directly below on a platform where an operative was performing a greasing task close by.

Had the strip of Hardox steel plate struck the employee, there would have been a potential for serious injury.

- The off-cut fell through open mesh flooring at height, missing an operative by 1 metre.
- The Fitter did not advise site Management of the task change but proceeded anyway.
- RAMS controls became ineffective as a result.
- Permit to Work - Hot works became ineffective

- Fitter re-inducted and trained in the process to follow.
- Review of contractual relationship with fitting contractor.
- Local Management re-trained in the Risk Assessment process.
- Implementation of a mid-task checklist for supervisory staff to carry out and audit checks during completion.
