# Insurance Inspector Near Miss

| INCIDENT No: | 00297 |

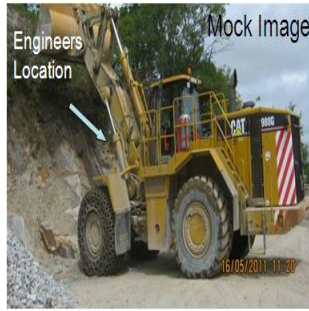
An insurance engineer was undertaking statutory inspections on a number of items of mobile plant at a UK Quarry. During the engineer's inspection of a CAT 998g loading shovel, the engineer was seen to be accessing the front of the Front End Loader (FEL) between the axles beneath a raised boom and bucket.

It was established that the loading shovel was switched off but the driver was still in the cab with the keys in the ignition. The plant operator had dropped the dead man switches to prevent movement of the stick controls, however he confirmed that he did not anticipate the engineer climbing on to the front of the FEL underneath the raised bucket.

When Questioned the FEL operator claims that the engineer could not be seen when he climbed on the front of the loader and eventually off over the wheel arch and front tyre.

- The Risk Assessment (RA) and Safe Working Practice (SWP) provided by the insurance company was not suitable & sufficient.
- The Quarry responsible manager did not effectively review the RA & SWP prior to issuing permission to proceed.
- The insurance engineer did not recognise the potential hazard of crushing / entrapment.
- The FEL operator was not fully briefed on the inspection method.
- The insurance company have a dynamic point of risk assessment tool, but the engineer was not aware of its existence and had not been trained in its use.

Always ensure that all task risk assessments manage all reasonably foreseeable hazards and the controls implemented are suitable and sufficient prior to issuing permission to proceed.
