Sudden Fluid Coupling Failure

LOCATION:	CEMENT PLANT
ACTIVITY:	MAINTENANCE & HOUSEKEEPING
SUB ACTIVITY:	N/A

ALERT STATUS:	Normal
DATE ISSUED:	03/09/2012
INCIDENT No:	00337

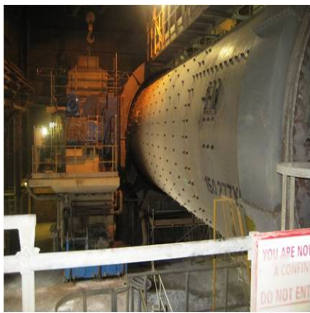
Cement mill with barring drive platform

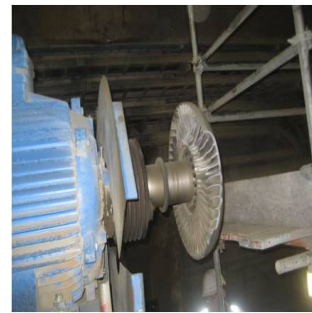
Shortly after commencing the inching operation the barring drive was stopped due to excessive load. Unfortunately the automatic shaft brake failed to hold the weight of the out of balance load causing the mill to drive the gearbox and fluid coupling in reverse. The gearing resulted in the coupling going in to over-speed and a loud “whooshing” sound was heard from the fluid coupling immediately prior to failure.

Remains of fluid coupling after failure

Immediate cause - An uncontrolled reversal of the mill resulting in excessive pressure due to overspeed within the fluid coupling.

Root Cause – The operation of the manual cooling water lance had not been adequately assessed when the modification was made. – Management of change.

- Develop and implement a straightforward and practical management of change procedure.
- Review and “HAZOP” study other similar installations where fluid couplings are installed in the drive train. Consider installing alternative drive arrangements (e.g. soft starts, inverters) and review the position of controls in relation to drive trains.
