Fatal 1 - Lorry driver near miss - Head stuck under tipper body

LOCATION:	CONSTRUCTION/DELIVERY SITE	ALERT STATUS:	Normal
ACTIVITY:	TRANSPORT & LOGISTICS / DELIVERY	DATE ISSUED:	08/07/2021 14:23:37
SUB ACTIVITY:	PRODUCT DELIVERY	INCIDENT No:	03595

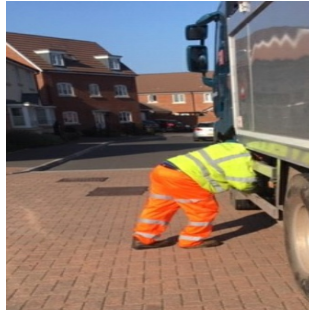
The lorry body design was such that an aluminium skirt around the bottom of the body sat approximately 6" from the side safety impact rail when the body was lowered.

As per the photo, when the driver leaned over the

side rail to retrieve the scraper the body slowly came down and trapped him between the two surfaces and resulted in being unable to get his head out.

Driver's head trapped

The haulage company re-trained ALL drivers in relation to their company handbook - in particular, tipping procedures.

The haulage company discussed the incident with the vehicle manufacturer to modify the locations / designs of skirts, toolboxes, controls, etc.
