# Operator injured by arm rest on CAT 980

ALERT STATUS: Normal  
DATE ISSUED: 30/11/2021 18:07:45  
INCIDENT No: 03599

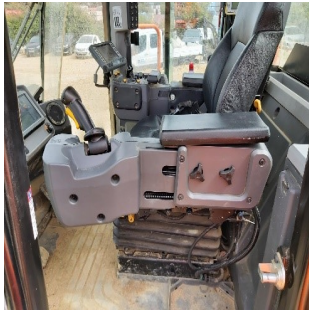
Armrest down

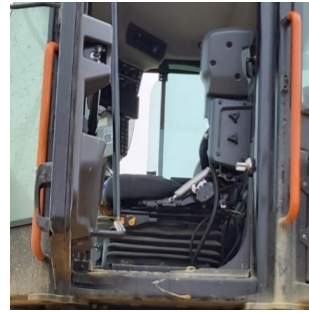
Armrest in up position to allow access

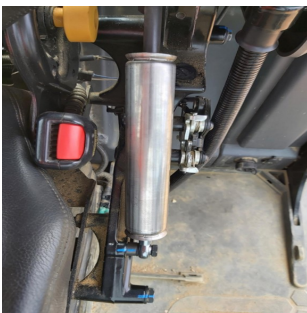
As the IP was lowering the unit back into the horizontal position, it become stuck. As the IP investigated the cause, the unit released and fell trapping the IP's finger.

An investigation identified that the connecting pin attaching the piston ram to the seat had sheered. At the time of the incident, the machine was three months old. Two other CAT 980s (delivered at same time) were also found to have a similar issue with the arm rest. All arm rests have now been modified in accordance with manufacturers instruction.

Faulty piston

2. Arrange with supplier for inspection to be undertaken of CAT 980 armrest.
