Eye injury whilst sampling concrete

LOCATION: READYMIX OR MORTAR PLANT
ACTIVITY: PRODUCTION AND PROCESSING
SUB ACTIVITY: READYMIX

ALERT STATUS: Normal
DATE ISSUED: 23/02/2022 11:06:20
INCIDENT No: 03607

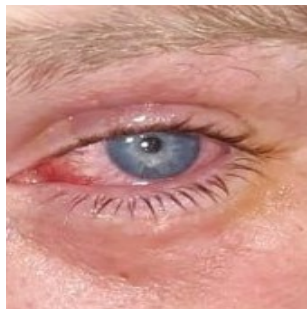
The technician's usual wheelbarrow for sampling had previously been used for the same load and was full of material. Therefore, a bucket was positioned beneath the truckmixer chute in order to take the sample, extensions were not added to the chute. The driver was unaware of the flowing nature of the material and, when operating the discharge controls, the concrete poured rapidly into the bucket. Due to the Technician's positioning, he was in the line of fire and concrete splashed into his face, getting behind his safety glasses.

The technician suffered a scratched eye, which resulted in him having to carry out restricted work duties for a short period.

- Incorrect equipment used for sampling.
- Technician positioned in line of fire.
- To reduce interactions during the pandemic sampling procedures were changed, this change resulted in alterations to usual working practices.
- Driver was unaware of product properties

- Carry out point of work risk assessment before a task and whenever a change occurs
- Fully inform others in working area of potential hazards
- Select correct PPE for task. Goggles may be more appropriate than safety glasses for some tasks.
