Fatal 6 - Spinflow Tipper Rollover

ALERT STATUS: High Potential
DATE ISSUED: 09/01/2023 14:38:17
INCIDENT No: 03632

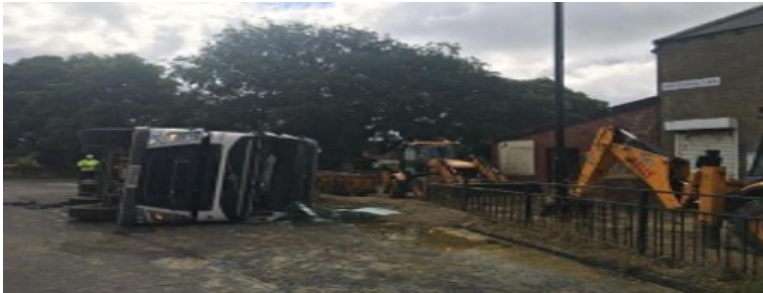
A Spinflow Tipper truck carrying 6m³ of Ready To Use Mortar rolled over when travelling round a roundabout. After missing a customer site entrance, the driver had to go to the next roundabout to do a full U-turn in order to gain access to the customer site; footage shows him not reducing speed as he approached the roundabout. A combination of speeding and the fluid material carried caused the vehicle to tip over when travelling round the roundabout. The driver was wearing a seatbelt and no loose objects were in the cab, so fortunately he was not injured but was badly shaken. No members of the public were involved, but it did cause traffic delays in the area and resulted in a large scale clean up operation

- The driver was employed by an Independent Haulage Contractor (IHC) and had 4 days training before been allowed to drive on his own
- The driver had 5 years driving experience, but not with Readymix products or vehicles
- The IHC did not notify the Operations team of the new starter and therefore had not received the company's Driver Induction
- Footage shows the driver did not adjust his speed for the road conditions and the road layout
- MP Connect system was not used to check base drivers
- The driver was wearing a seatbelt and no loose items were in the cab

- The IHC Should have notified the operations team of the new driver, so he could be inducted and reviewed for competence
- Had the depot used the MP Connect sign-in, they would have known about the new driver
- All drivers should drive below the limit and adjust speed to suit vehicle type, loading, weather and road conditions

- Ensure all new drivers receive the company driver induction and review competence for specific vehicle types
- Carry out regular Driver VFLs
- Review MP Connect system process to include base drivers
- Review IHCs Training policy and sign off
