Tyre Fitter Entrapment

WHAT HAPPENED

03634

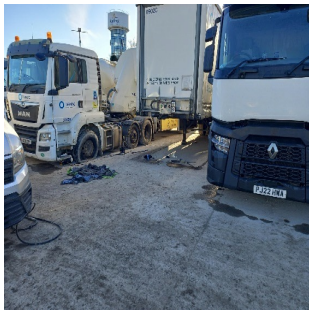
The image shows the tractor unit the tyre fitter was working on. The fitter became trapped under the steps of the unit when it appears that the jack, he was using to lift the unit to change the tyre failed or became dislodged (the company is still waiting for the completion of the investigation).

Wheel chocks and secondary axle supports should have been installed as part of the works but were not. The wheel chocks are used to prevent truck movement during works and the secondary supports are used to support the unit should a jack fail or become dislodged.

- The IP did not use either secondary axle supports or wheel chocks during their work. These requirements were part of the method statement. On investigation secondary supports were found to be within the fitters van, wheel chocks could not be found in the van.
- The IP had used an access code to get through gates that provided security to the site, failed to call security when at the gate, failed to report to the weighbridge as would be the norm, drove to the HGV trailer park within the site and commenced works.
- They did not notify anyone of their arrival (investigations continue as to how the fitter got the access code but current investigations identify this was not given to them by the company)

- Please use this briefing as an awareness piece, identifying to those who manage contractors the key controls identified to be used when a vehicle is lifted by jack for maintenance works.
- Following the incident take opportunity to review access and egress points to your sites to ensure secure and managed as is reasonably practicable.
