Fatal 1 - LOTOTO - Failure to correctly follow isolation procedure when undertaking maintenance work

LOCATION: CONCRETE PRODUCTS PLANT
ACTIVITY: GUARDING AND ISOLATION
SUB ACTIVITY: NO SUB ACTIVITY AVAILABLE

ALERT STATUS: Normal
DATE ISSUED: 22/06/2023 13:20:06
INCIDENT No: 03646

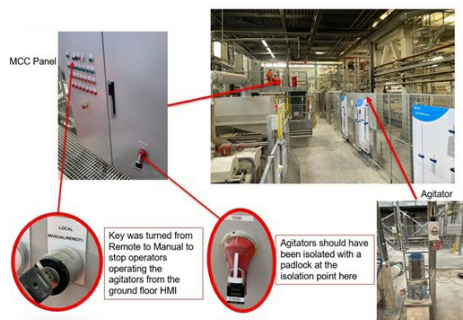
In April 2022 a plant was in the process of carrying out its yearly engineering shutdown. One of the planned tasks was for operators to dig out the vac crust pit located under the vac and cutting line. The operators had taken out the castell key to enter the vac area and put into the lock box. All the operators individually locked off to the box securing the area to work in, then entered the area and began to dig out the crust pit. While carrying out a walk of the area, a safety rep and maintenance manager identified the agitators within the area were switched off (To "Manual") on the MCC panel on the mezzanine floor but the panel was not fully isolated, and no isolation document had been completed.

Although a LOTOTO SOP for this task was present and clear, including all the isolation points, the responsible person failed to own the isolation process and to make sure all the measures were in place before work commenced.

- Share this incident with all company sites
- Review site isolation process and training in line with the company standard, and site shut down procedure
- Find engineering solutions to simplify the isolation process in line with best practice
