Slip, trips and falls - operator cut on knee following trip in yard

LOCATION:	DEPOT	ALERT STATUS:	Normal
ACTIVITY:	MANUAL HANDLING AND STORAGE	DATE ISSUED:	30/07/2023 20:50:22
SUB ACTIVITY:	AGGREGATES	INCIDENT No:	03656

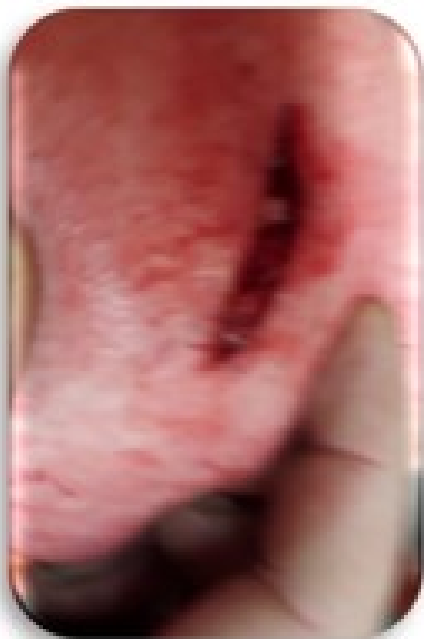
The IP began to offload the a vehicle, it was dark due to the time, but the yard was floodlit. He was offloading sandbags onto the pallets where the sandbags are stored. A gully had been left on the floor next to the pallet by sub-contractors. Not seeing the gully whilst walking and fell causing a gash to his knee. The resulting injury was a cut to the knee that required stiches at the local A&E.

- Area was lit by flood lights however shadows cast by the vehicle may have caused the object to be less visible than normal
- The gully had been left on the floor by a sub-contracting gang working for contracting
- The driver had not inspected the area before beginning to work in the area

Gully left along vehicle
by sandbag area

- Lighting of yard areas and outdoor workspaces to be inspected and critical areas of pedestrian movements and work areas are illuminated sufficiently taking in to account any shadows that me be initiated by other objects
- Daily inspections of work areas are undertaken and any unsafe conditions or concerns to be raised through line management and recorded on Intalex
- Housekeeping inspections are to be undertaken regularly to ensure equipment is stored in a safe manner and any items or areas not meeting minimum standards are improved and those with the responsibilities are held accountable
- Areas of specified equipment is sufficiently identified by clear signage and instruction
