**Fatal 5 – Employee sustains face injuries whilst assisting in the movement of a suspended load with a telehandler.**

LOCATION:	WHARF	ALERT STATUS:	Normal
ACTIVITY:	LIFTING	DATE ISSUED:	29/11/2023 10:15:26
SUB ACTIVITY:	NO SUB ACTIVITY AVAILABLE	INCIDENT No:	03677

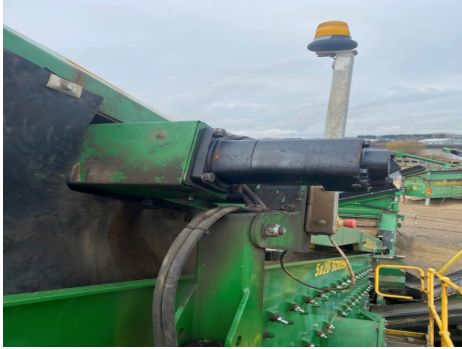
The motor on a mobile screen on a wharf was leaking hydraulic oil. The wharf foreman was asked to remove the motor prior to the attendance of contractors, to allow them to fit another motor from consignment stock; a task that had been carried out on previous occasions.

Image of motor in position

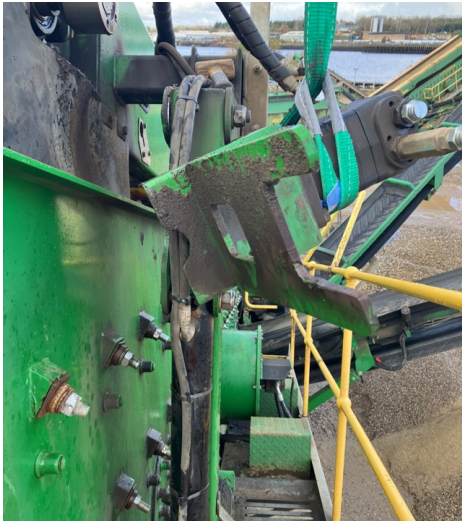
The foreman had been advised to get assistance from a site operative. The weight of the motor was supported by a telehandler. The incident occurred when the final bolt was released from the motor. As the motor was pulled back, it snagged on the torque plate brace. The operative tried to release the snag and the motor freed and then, because it was attached to strops suspended from the telehandler, it rotated anti clockwise hitting the operative's safety helmet, which pushed into his forehead causing a laceration. The motor continued to rotate, with the torque plate striking the right-hand side of the operative's nose. He was taken to hospital where he required 3 stitches.

Image of motor suspended

- Specific RAMS and Lift Plan should have been in place to identify the most appropriate method of work, and ensure when the task didn't go to plan, it was stopped allowing the RAMS and Take 5 to be reviewed.
- The weight of the motor was being supported by a strop wrapped around the motor attached to the telehandler. The foreman operating the telehandler and operative were communicating through an open window. Use of a Hiab may have improved communication and allowed the person guiding the lift to stand on the work platform; alternatively, use of a pull lift would have provided greater control of the tension placed on the motor.
- Rather than attempting to release the motor by hand, use of a guide rope would have avoided the need to be "in the line of fire".
