FATAL 5 - Operative sustains impact to chest when struck by a manifold during a crane lift

ALERT STATUS: High Potential
DATE ISSUED: 22/02/2024 18:43:33
INCIDENT No: 03697

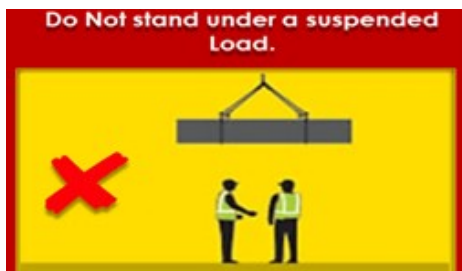
During the lift the manifold became caught on a protruding bolt, the maintenance operative approached and levered the manifold off whilst the load was still in tensions in 'lift'. When the load was freed, it swung back and struck the IP who suffered bruising to their ribs. Click on additional pdf to see summary of this alert.

1. Clear assessment of the hazards must be completed prior to any job, all parties involved must discuss and agree, then sign the risk assessment and method statement.
2. Exclusion zones to be maintained to only allow designated crane team into the lifting area.
3. For further information on lifting please follow this link to the HSE web page on lifting <https://www.hse.gov.uk/construction/safetytopics/lifting-operations.htm>
4. Please see below examples of signage that could be used in area where a lifting operation is taking place

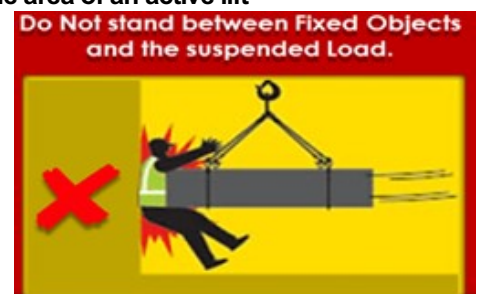
Never enter the area of an active lift
