# A maintenance inspection of bitumen tank uncovers severe corrosion at base of tank

LOCATION: ASPHALT/COATING PLANT  
ACTIVITY: MAINTENANCE & HOUSEKEEPING  
SUB ACTIVITY: ASPHALT & COATED STONE

ALERT STATUS: High Potential  
DATE ISSUED: 19/08/2024 15:45:04  
INCIDENT No: 03729

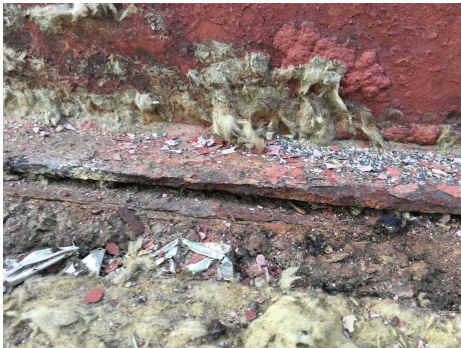
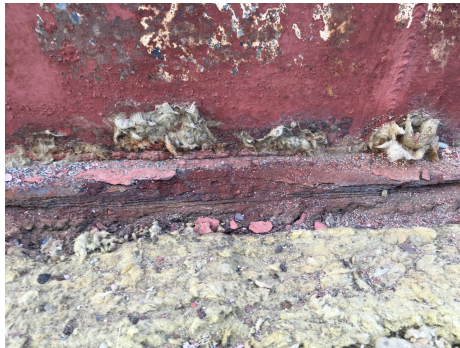
Significant corrosion was discovered at on the steel at the base of the tank walls and further inspection revealed that the thickness of the tank wall had decreased by 75%.

This was due to moisture ingress into the insulation of the tank, with the combination of heat, water and oxygen causing significant corrosion. The images below show the corrosion at the base of the tank.

There are two possible actions to mitigate the effects of moisture on the tank walls:

- Removal of insulation from the base of the tank (100-150mm)
- Incorporation of stainless steel, rather than mild steel for the bottom 1.5m of the tank walls.
