Explosion in a High Voltage Substation

CEMENT PLANT
PRODUCTION AND PROCESSING
CEMENT PRODUCTION

ALERT STATUS: Normal
DATE ISSUED: 08/02/2014 13:50:00
INCIDENT No: 00374

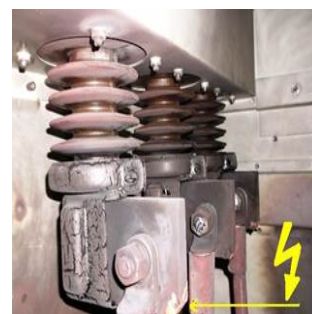
Phase to Phase Discharge

The initial inspection of the components below the vacuum circuit breaker indicated that there had been a phase to phase discharge within the termination chamber (evidence of this is shown in the photo where a discharge occurred between the edge of the busbar nearest the photo and a second phase). It was confirmed that there was no fault to earth.

Subsequent examination of the cable involved, indicated that the Raychem heat shrink insulation applied to one of the phases was showing signs of heat damage with some partial melting. The insulation is an orange colour and is used to protect the core when the outer insulation is stripped back during installation.

After consideration of possible causes, an inherent cable fault was considered very unlikely as no evidence of this has been identified (the cable terminations are subject to further test and examination). The remaining two potential faults were considered equally likely.

1. No access to the rear of HV switchgear at any time until further measures are adopted (previously this was only during switching operations). The “no access” areas are marked by a red painted floor in prohibited areas.

2. Transient earth voltage (TEV) meters (two off) have been ordered which are designed to identify and warn of partial discharge (PD) when working in the close proximity of HV equipment.
