# Fatal 5 - Gasket failure at asphalt plant resulting in bitumen spill

**LOCATION:** ASPHALT/COATING PLANT  
**ACTIVITY:** MAINTENANCE & HOUSEKEEPING  
**SUB ACTIVITY:** ASPHALT & COATED STONE

**ALERT STATUS:** Normal  
**DATE ISSUED:** 21/10/2024 15:42:42  
**INCIDENT No:** 04839

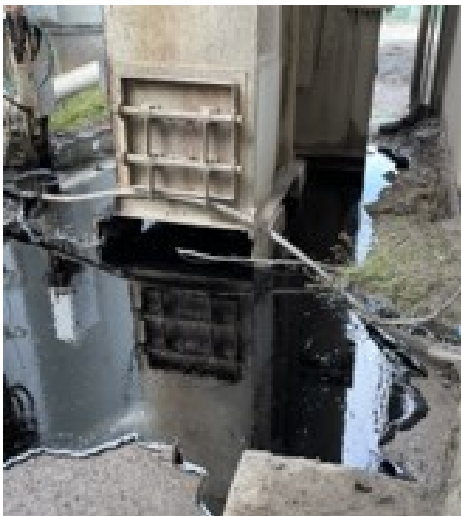
A failure in the bitumen trace heating system on an asphalt plant resulted in the pipework cooling. After the trace heating was repaired the pipework was brought back to the operating temperature. The plant was then started successfully, mixing 6 tonnes without any problems. However, as the manager passed by the bitumen system, he observed bitumen leaking beneath the pump cover box. He promptly notified the plant operator, leading to the shutdown of the equipment.

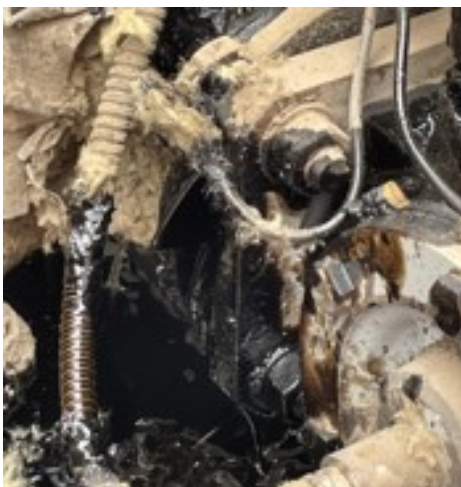
**Pipework** - The pipes connected to the pump were installed at an angle, it is likely that this complicated the installation of the sealing gaskets during the pump's fitting. Additionally, the pump flange was square while the pipe flange was round, and a portion of the flange had been removed to accommodate the bolts on the side where the failure occurred.

**Gasket** - The gasket appeared to have been 'pinched' during installation, resulting in a vulnerable area that permitted the gasket to split. The image shows the location of the failed gasket.

Assessing the existing condition of equipment, ensuring components are compatible, standardisation of equipment where practical, considering the consequences if a failure was to occur.

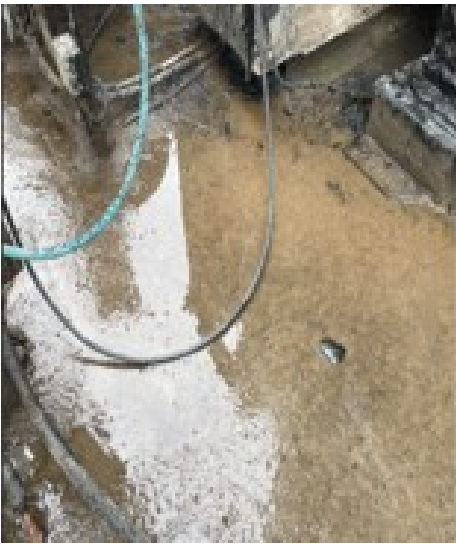
**Air system** - The cables and air pipes were raised, apart from one pipe positioned at ground level. This pipe ruptured when it became enveloped in bitumen, resulting in a spray of hot bitumen at an approximate temperature of 135-140 degrees being projected upwards.

- Review bitumen systems to determine if there are water or air pipes situated at ground level that may come into contact with bitumen in the event of a spillage from any section of the system.
- Is the bitumen pump adequately shielded to prevent the outward spraying of bitumen?
- Are all flanges enclosed to prevent bitumen spray in the event of a seal failure?
- Are relevant inspections in place for bitumen systems?
- Are there signs of leaking from pipework?
- It is essential to promptly address and repair any leaking bitumen pipework.
