# Fatal 5 - Quarry face collapse during drilling operation

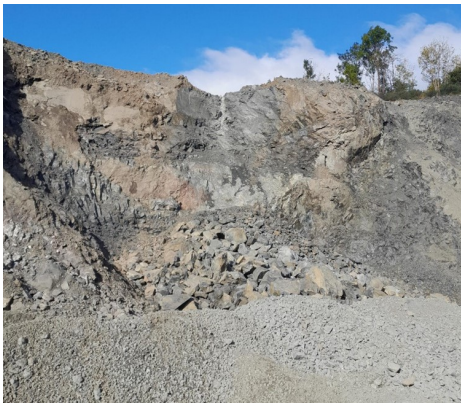
A drilling contractor was on-site at a quarry and whilst drilling the first row of holes, the face collapsed with approx. 100 tonnes of material falling to the quarry floor.

Upon investigation, it was found that there was a seam of dark brittle material which when drilled caused a plane failure. This had been highlighted in the most recent geotechnical assessment and had been placed on a site specific geotechnical action plan, but neither of these documents had been checked prior to the drilling being carried out. The image below shows the face collapse.

- Ensure all safety control measures are in place before drilling begins (i.e. suitable rock traps, safe stand off at drilling area etc.)
- Ensure the most recent geotechnical assessment report and action plan are available and have been checked for any areas of instability or potential areas of failure where drilling is taking place.
- Ensure a suitable standoff is maintained by the drill rig operator from the crest of the face and that the drill rig can be moved to a suitable place of safety in the event of an emergency.
- If in any doubt about the area to be drilled, STOP, and get specialist advice before proceeding.
