Quarry Contractors – Failure by a contractor to perform an earthmoving operation at a quarry safely - highlights responsibilities of company to manage contractors undertake the task safely

LOCATION: QUARRY
ACTIVITY: QUARRYING AND FACE ACTIVITY
SUB ACTIVITY: NO SUB ACTIVITY AVAILABLE

ALERT STATUS: Normal
DATE ISSUED: 17/03/2025 15:04:13
INCIDENT No: 04862

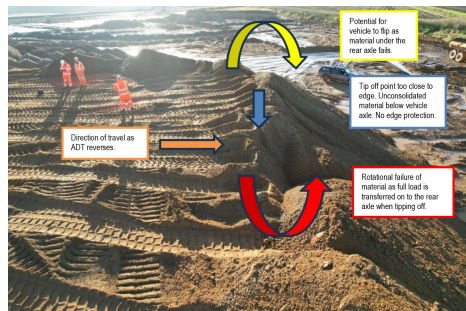
- Non-compliance with the company's PPE policy – identified during VFL visit and subsequently not acted upon.
- Lack of notification to relevant Quarry Responsible Manager when accessing site.
- Failure to stockpile mineral as per design document, including:
 - Ensuring correct material compaction (to minimise geotechnical instability).
 - Excessive height of stockpile.
 - High risk end tipping activities. End tipping is forbidden on all the company sites.
 - Missing edge protection
 - Inaction following previous improvement request.

View from above the stockpiled material

- Please could all quarry responsible manager's ensure they reiterate the importance of these omissions to all relevant quarry colleagues including internal plant operatives and external contractors.
- Ensure that each site's appointed personnel is competent to advise on these risks in the context of safe operation of quarries in minimising geotechnical instability and unsafe acts.
- Please check the quarry's Excavation and Tipping Rules to ensure they are up to date and relevant to the site – requesting assistance from LMR where required.
- Even if the contractor supplies a floor-based supervisor, as an appointed person you need to be vigilant and ensure that you carry out your inspections and manage the contractors.

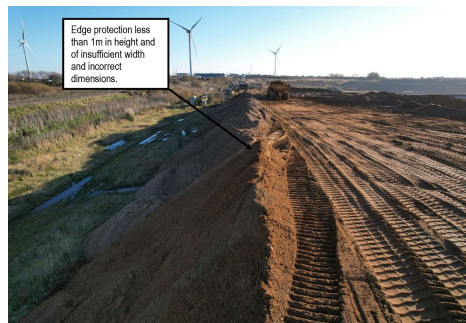
The edge protection

- On quarry benches or roads used by heavy vehicles, the minimum acceptable height of the edge protection is 1.5m or the radius of the largest wheel/tyre – **whichever is greater**. Additional protection is needed in high-risk areas, such as sharp bends or steep haul roads, where sand traps should also be considered

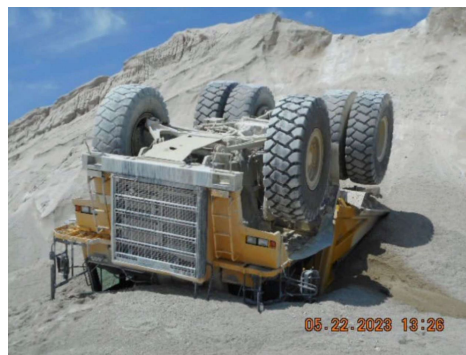
Please see below an example of **end tipping** that occurred in the USA. This incident resulted in a fatality.

- Below are the basic parameters of good and bad edge protection, taken from Regulation 13.
- When tipping material on top of a stockpile or tip, the load must be dispensed at least 6 metres from the break in slope. A suitably sized bulldozer must then push the material over the edge, whilst maintaining their tracks on relatively compacted ground.
