TRANSPORT - Fatal 5 – Chain snaps whilst seeking to pull a readymix truck from mud.

LOCATION:	CONSTRUCTION/DELIVERY SITE	ALERT STATUS:	Normal
ACTIVITY:	TRANSPORT & LOGISTICS / DELIVERY	DATE ISSUED:	02/06/2025 20:33:34
SUB ACTIVITY:	DELIVERING READYMIX	INCIDENT No:	04876

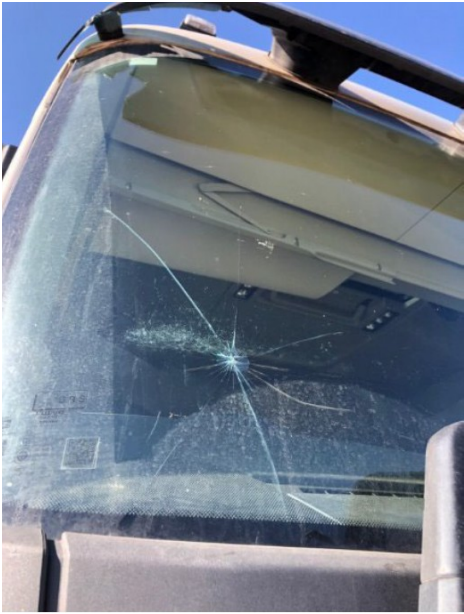
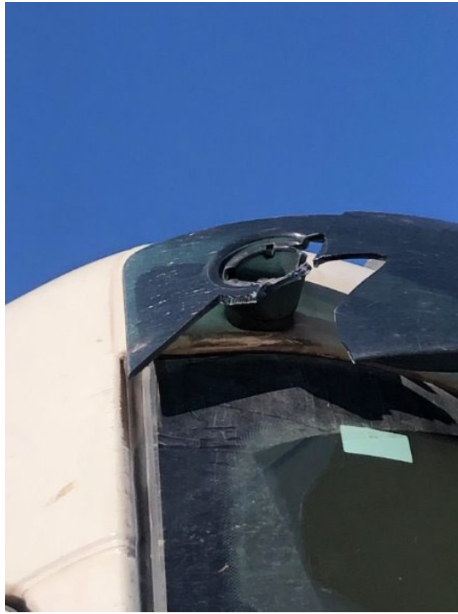
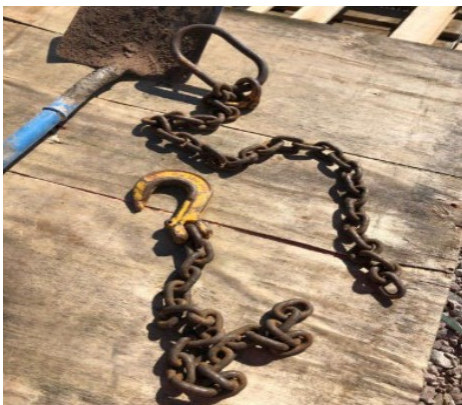
On the initial towing attempt, a single chain was utilised. Under tension, the chain failed and snapped, propelling a section of it through the air. The chain struck the mixer vehicle's windscreen directly in front of the driver's seated position. A subsequent attempt was made using multiple chains; however, one of these also failed under load.

As a result of these incidents, the mixer vehicle sustained damage to both the external sun visor and the windscreen. The outcome could have been far more serious if anyone had been struck by the chain.

The images show the broken chain and damage to the windscreen and cab of the mixer truck

- An investigation identified the following root causes.
- No Take One Risk Assessment carried out to determine hazards and controls
- No procedure in place for the self-recovery of the vehicle
- Lack of information, instruction and training provided to the driver
- Incorrect equipment used to recover the vehicle

- Towing of stranded vehicles shall only be carried out by competent persons following a robust Risk Assessment & Method Statement using only approved equipment.
- Chains or ropes must never be used for towing.
- Working group established to create a safe self-recovery procedure.
- Driver onboarding schedule updated to include towing restrictions along with annual refresher training and driver pack.
- Safety tags added to towing eyes to prompt management contact and requirement for a Risk Assessment prior to use.
