Fatal 5 - Two large metal wear plates fell from a mixer via the discharge cone onto the loading bay floor

LOCATION: READYMIX OR MORTAR PLANT
ACTIVITY: PRODUCTION AND PROCESSING
SUB ACTIVITY: READYMIX

ALERT STATUS: Normal
DATE ISSUED: 09/06/2025 18:29:12
INCIDENT No: 04908

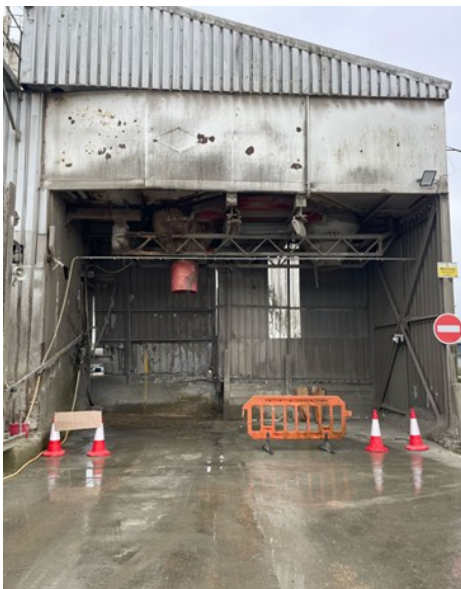
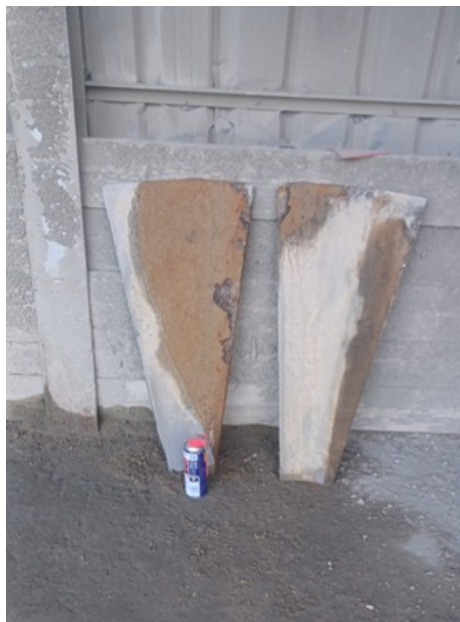
After a truck mixer pulled forward out from the loading bay after being stoned out, two large sections of steel lining fell from the discharge cone and onto the ground.

Investigation identified the steel wear plates were historic items, and had been tack welded rather than the use of a more permanent fixing.

The images below show the loading bay with the orange coloured cone, and the two steel lining plates that fell.

- Ensure pedestrian access to loading area is restricted.
- Review controls on site to ensure pedestrians in particular mixer drivers are not able to inadvertently enter the loading area.
- Review inspection regimes to ensure the suitability of fixings is captured.
