# MOBILE PLANT - Fatal 5 - Tractor loses wheel on quarry haul road.

**ALERT STATUS:** Normal  
**DATE ISSUED:** 12/06/2026 00:11:32  
**INCIDENT No:** 04977

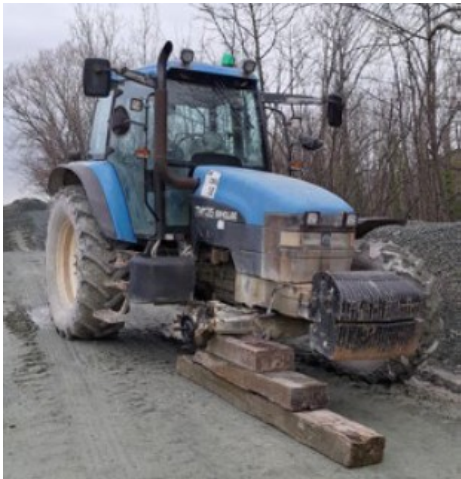
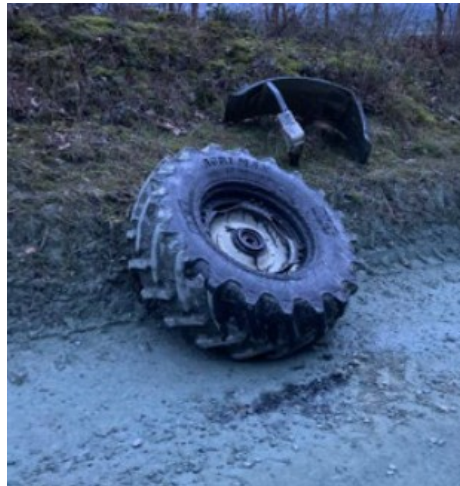
A New Holland tractor was travelling up the incline on a quarry haul road when the wheel hub failed causing the wheel to detach from the tractor.

An investigation identified the following root causes

- Improper extension of service life of equipment
- The hub assembly had operated for many years without inspection
- No formal checks in line with original equipment manufacturer (OEM) recommended service intervals
- Servicing had been moved in house with improper management of change.

- Service interval on Checkproof for tractor to include OEM specific checks.
- Identify all assets over 15 years old for immediate life extension inspections.
- Develop component life cycle matrix auxiliary equipment and implement annual health check on Checkproof.
- Service on Checkproof to include full-service document and annual health check document, with person responsible to receive alert.
