Incident Date:	11 th December 2013	Location:	Perth
Safety Alert Date:	16 th December 2013	Country:	Australia
HSE Outcome:	Grease Injection into small finger, surgery, hospitalisation		
Equipment Involved:	Hand Activated Grease Gun		
Root Causes:	Operator was attempting to remove hand grease gun from grease nipple after pumping several times and finding it hard. In gripping hose and manoeuvring it the hose ruptured, injecting grease into little finger.

INCIDENT

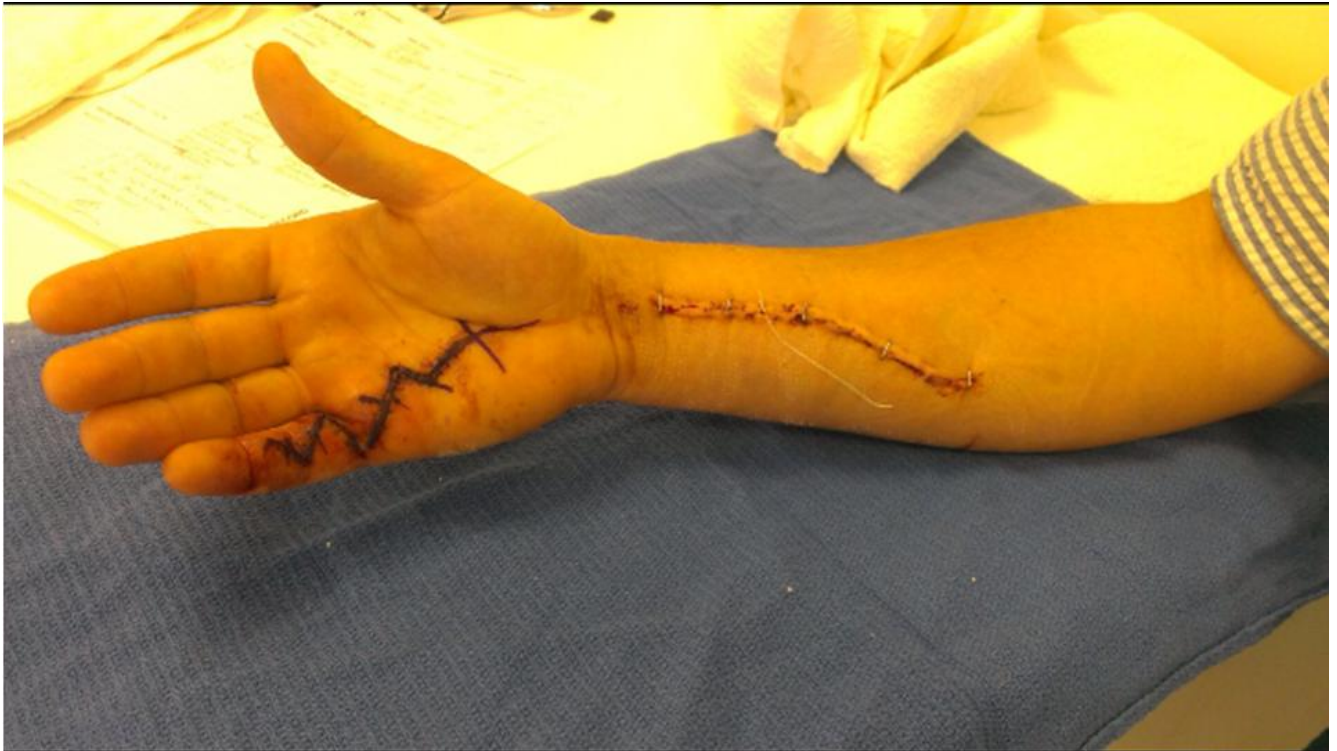
OPERATOR WAS USING A **HAND HELD GREASE GUN** TO LUBRICATE VARIOUS GREASE POINTS ON EARTH MOVING PLANT.

OPERATOR ONLY FELT A SHARP PRICK TO LITTLE FINGER AND ON INSPECTION NOTICED A SMALL HOLE. ON SQUEEZING FINGER APPROXIMATELY ONE TEASPOON OF GREASE WAS EJECTED. N.B. – GLOVES WERE NOT BEING USED AT THE TIME.

MEDICAL ATTENTION WAS SORT RESULTING IN A LENGTHY OPERATION AND REMOVAL OF A VEIN IN THE FOREARM. THIS WAS REPLACED WITH AN ARTIFICIAL VEIN.

- INSPECT EQUIPMENT PRIOR TO USE TO ENSURE IT IS IN SOUND WORKING ORDER WITH NO CUTS, DAMAGE.
- CHECK AND TIGHTEN ALL FITTINGS.
- WEAR SUITABLE PROTECTIVE GLOVES WHEN USING ANY EQUIPMENT WITH STORED ENERGY POTENTIAL.
- EVEN RELATIVELY LOW PRESSURE EQUIPMENT HAS THE POTENTIAL TO INFLICT HYDRAULIC INJECTION INJURY.
- GREASE GUN HOSE WAS NOT A STRENGTHENED HYDRAULIC PRESSURE (WOVEN/MESH) TYPE BUT OF RUBBERISED COMPOUND ONLY.
