# Crack on Dumper

Crack found on CAT 771D Dumper.

LOCATION:	QUARRY	ALERT STATUS:	Normal
ACTIVITY:	MAINTENANCE & HOUSEKEEPING	DATE ISSUED:	19/03/2007
SUB ACTIVITY:	N/A	INCIDENT No:	00124

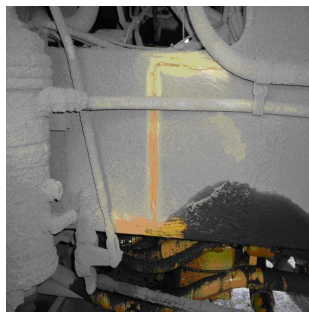
The crack was identified when the dumper was in the fitting shop having a tyre changed. A maintenance contractor was called in to make the necessary repairs, when the welder gouged out the crack it became clear that there was no backing plate behind the crack. There should have been a 4 inch plate each side of the crack to support the weld. The findings have been passed on to Finnings and an explanation requested.
