Crack on Dumper

Crack found on CAT 771D Dumper.

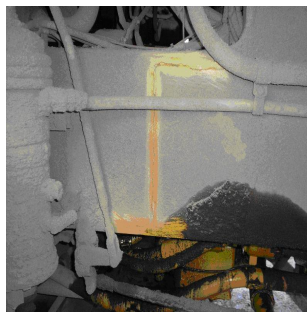
The crack was identified when the dumper was in the fitting shop having a tyre changed. A maintenance contractor was called in to make the necessary repairs, when the welder gouged out the crack it became clear that there was no backing plate behind the crack. There should have been a 4 inch plate each side of the crack to support the weld. The findings have been passed on to Finnings and an explanation requested.
