INCIDENT ALERT

LOCATION:	CONSTRUCTION/DELIVERY SITE	ALERT STATUS:	Normal
ACTIVITY:	TRANSPORT / DELIVERY	DATE ISSUED:	10/07/2007
SUB ACTIVITY:	ON-HIGHWAY	INCIDENT No:	00130

Tipper Overturn Whilst Unloading

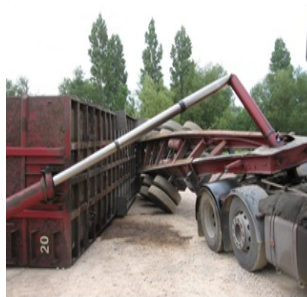
The driver arrived on site and signed in at the weighbridge and made his way to the tipping point. After opening the doors and examining the load he was concerned that the load had settled to one side, against the nearside of the trailer. He then began to tip and noticed the trailer beginning to lean. He lowered the trailer body and asked the loading shovel driver to put a small amount of material in to even the load out. The shovel placed approximately 5 ton into the lorry. The driver then began to tip the load. He climbed out of his cab to check to see if the body was going up squarely. The driver noticed that the body was leaning and went back to the tractor unit to disengage the lifting ram but before he could do this the ram bent and the trailer went over. Fortunately the tractor unit was only lifted a short distance. The primary cause appears to be a build up of load over one side of the trailer body between the rear axle of the tractor unit and the first axle of the trailer. The ground was even and flat.

The aftermath of the event

3. Drivers should be aware that in older trailers, placing additional weight in the area between the rear axle of the tractor unit and the first axle of the trailer is likely to cause increased instability, particularly in those trailers with square sides. Further instability is caused if the load has bound together in this area due to being damp or being loaded unevenly allowing for a sudden shift in weight whilst tipping.

1. Truck drivers should always remain in their cabs, with their seat belt on, when tipping loads.
2. Truck drivers should not attempt to return to their cabs whilst the truck is tipping over! See point 1.

4. Loading shovel drivers should avoid placing additional material into trailers in order to 'even the load'. Should a hazard be identified then better communication between loader driver, weighbridge clerk and site management is paramount. A thorough assessment of risk should have been carried out.
