Neck strain sustained whilst descending from loading shovel

00131

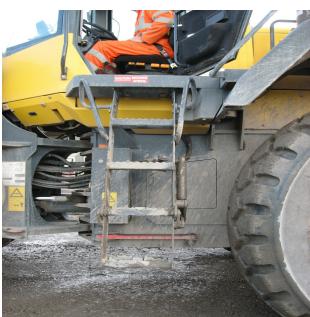
Hydraulic Flexi Step

A hydraulic step system has been ordered for the loading shovel. All personnel should be aware of this type of 'flexi' step and where possible, a new step system should be discussed and fitted, similar to the one shown below.
