## INCIDENT ALERT

<b>LOCATION:</b>	<b>ON-HIGHWAY</b>	<b>ALERT STATUS:</b>	<b>Normal</b>
<b>ACTIVITY:</b>	<b>TRANSPORT / DELIVERY</b>	<b>DATE ISSUED:</b>	<b>24/06/2015 11:22:58</b>
<b>SUB ACTIVITY:</b>	<b>TIPPER</b>	<b>INCIDENT No:</b>	<b>01416</b>

**Tipper Body Floor (Steel Liners)**

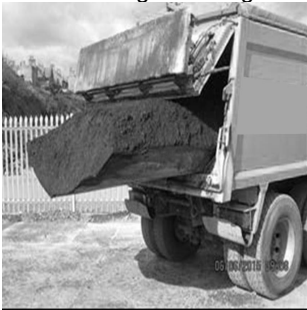
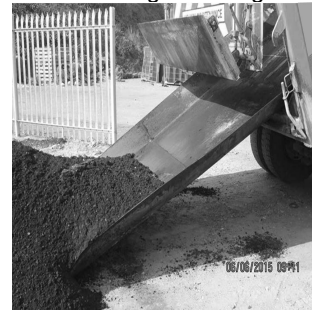
Recently on a contract surfacing site; a tipper truck was delivering asphalt to a machine lay operation. During the discharge of the load, the tipper body floor as a whole moved, as illustrated in the photographs.

After investigation it appears that the cause of the failure was that the fixings used to secure the liner to the body had corroded and failed as a result of galvanic corrosion, which is an electrochemical process. There has been a reaction between the alloy body and steel liner, which has caused the fixings to corrode and fail.

Since this incident, all the steel inserts have been thoroughly inspected and a replacement programme to fit an aluminium welded floor is underway. These trucks have been taken off asphalt deliveries until these steel inserts have been removed.

Truck drivers were instructed to inspect the tipper body floor as part of the daily checks for wear etc. and to report any defects immediately.
