Equipment mounted at height

CONCRETE PRODUCTS PLANT
MAINTENANCE & HOUSEKEEPING
N/A

ALERT STATUS: Normal
DATE ISSUED: 21/04/2016 13:23:27
INCIDENT No: 01428

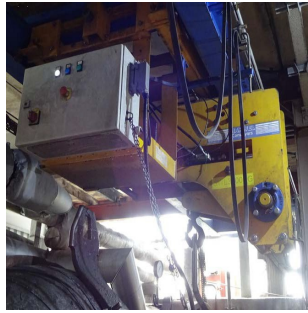
This alert is issued following a previous alert regarding the failure of a drive motor and gearbox mounted at height.

- Ensure Planned Preventive Maintenance (PPM) is scheduled in line with manufacturer's recommendations as a minimum
- In harsher environments and high usage, more frequent inspection may be required.

- Ensure all materials used in the PPM or breakdown repairs meet with the manufacturer's specification, and any other technical standards that may apply.

- Where individual component parts require replacing consider the benefit of replacing the whole assembly to avoid the potential for backlash.
- Carry out assessments identifying areas where equipment is mounted / travels over people, consider fitting a secondary securing device.

- Secondary securing devices prevent a component falling from height if the primary securing method fails. This could be a safety wire or some other engineered method designed for this function. Secondary securing devices should be sufficient to withstand the shock loading that may occur if the primary securing method fails.

- Encourage employees to maintain vigilance and report concerns with machinery (for example: report strange noises / changes in operating performance as potential hazards).
