# Catastrophic failure of clamp on forklift

**LOCATION:** CONCRETE PRODUCTS PLANT  
**ACTIVITY:** MANUAL HANDLING AND STORAGE  
**SUB ACTIVITY:** N/A

**ALERT STATUS:** Normal  
**DATE ISSUED:** 27/04/2016 15:34:34  
**INCIDENT No:** 01429

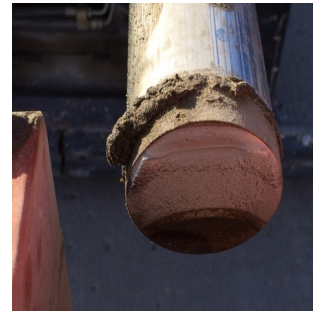
A clamp which was attached to a Linde HD 50 forklift failed catastrophically when a steel rod sheared. This resulted in a pack being dropped as it was being placed on the ground. The incident could have been much worse as packs can be stacked 4 to 5 cubes high at full extension. No injury occurred during the incident, but the potential was far greater. Investigations identified that the clamp and truck had been in service just under three years and that the clamp attachment had been serviced within the last 9-10 months.

Sheared rod on clamp

- The service of the clamp attachment and inspection routines failed to pick up this fault
- Existing clamp attachments should be checked / inspected by NDT to ensure they are crack free
- Amend service routine to cover NDT of area of rod that failed
- Review frequency of inspection and service
