Tyre fitter trapped under foam filled tyre

INCIDENT No:

01432

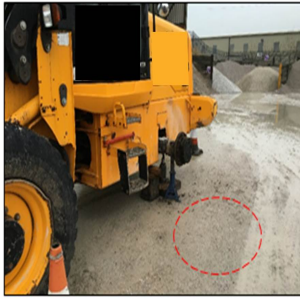
A contract tyre fitter (IP) working on a hired loading shovel suffered bruising to his right arm and left leg after becoming trapped beneath a foam filled tyre and wheel assembly, when the tyre fell onto him after he unbolted the wheel in preparation for changing the tyre - see Photograph 1.

- The loading shovel was on hire and neither the Company nor the tyre fitter knew the tyre was foam filled.
- The IP assumed it was a punctured air-filled tyre because it had deflated (the foam inside the tyre had deteriorated giving the appearance of a punctured pneumatic tyre – foam tyres don't normally deflate).
- The foam filled tyre weighed in excess of 400kg (two or three times heavier than an air filled tyre). It took two people to lift the tyre off the trapped fitter.
