INCIDENT ALERT

LOCATION: CONCRETE PRODUCTS PLANT
ACTIVITY: LIFTING
SUB ACTIVITY: NO SUB ACTIVITY AVAILABLE

ALERT STATUS: Normal
DATE ISSUED: 29/07/2016 12:16:52
INCIDENT No: 01437

Collapse of concrete flooring during construction

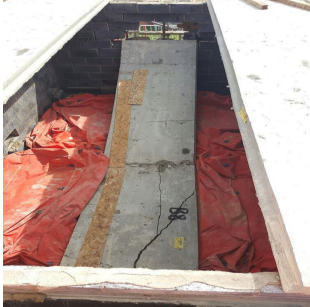
An incident recently occurred during the construction phase of a housing development. A precast concrete hollowcore flooring slab fell from first floor level onto the ground below. No persons were injured.

Fig. 1 - Damaged slab on ground

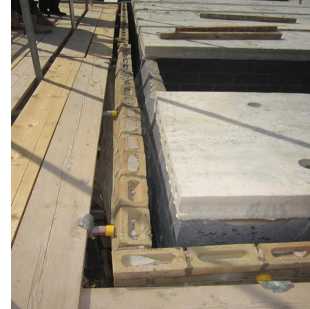
- (i) Failure of the bearing (reason unknown), or
- (ii) The slab being dislodged from its bearing.

Fig. 2 - Supporting masonry

Responsible persons should be reminded of the importance of carrying out suitable and sufficient pre / post installation inspection (with should include ensuring no damage in transit or installation and the suitability of load bearing points)
