INCIDENT ALERT

LOCATION:	MOBILE PLANT	ALERT STATUS:	Normal
ACTIVITY:	TRANSPORT / DELIVERY	DATE ISSUED:	05/12/2016 16:05:27
SUB ACTIVITY:	LOADING	INCIDENT No:	01444

Incident involving the transport of dump trucks 50 tonnes and over

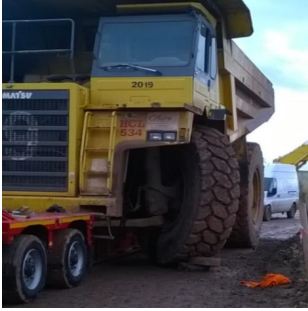
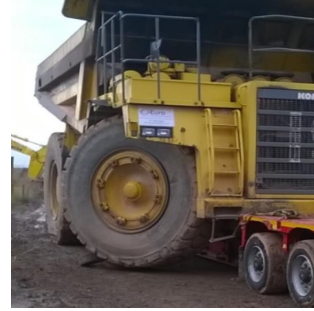
On assessing the site, it appears that the wheels had turned from parallel to the vehicle sides to their final resting position, by the offside rolling forward off the block on which it was elevated; and the near side rolling backwards.

What is not clear, is what caused this movement, from what had been a stable position for some time; to slow initial movement and then quicker in its final moments. The fact that the nearside tyre was not inflated to the same level as the off side one and the vehicle had not run for some time may have been contributing factors.

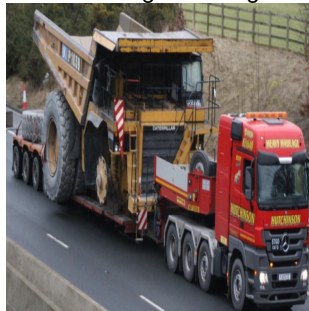
This DT was collected on a beam trailer, without the mattress boards on either side being installed, which gave the space for the wheel to pivot.

By installing these mattress boards, the width across the trailer is increased, limiting the space for movement of the wheel if this were to pivot. The use of low loader trailers would have a similar limiting effect, protecting anyone working in the wheel arches from being trapped.
