Incident involving the transport of dump trucks 50 tonnes and over

LOCATION:	MOBILE PLANT	ALERT STATUS:	Normal
ACTIMTY:	TRANSPORT & LOGISTICS / DELIVERY	DATE ISSUED:	05/12/2016 16:05:27
SUB ACTIVITY:	LOADING	INCIDENT No:	01444

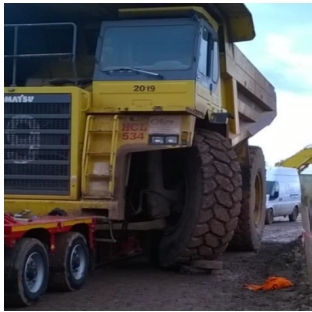
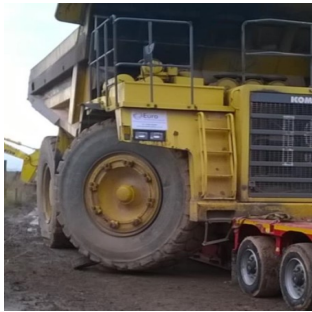
On assessing the site, it appears that the wheels had turned from parallel to the vehicle sides to their final resting position, by the offside rolling forward off the block on which it was elevated; and the near side rolling backwards.

What is not clear, is what caused this movement, from what had been a stable position for some time; to slow initial movement and then quicker in its final moments. The fact that the nearside tyre was not inflated to the same level as the off side one and the vehicle had not run for some time may have been contributing factors.

- The fact that the wheel moved while on the single sleeper, suggests this is not the ultimate solution as without the excavator bucket in place, the forces involved could move the sleeper
- What was required is something that physically stopped the wheels from pivoting.

This DT was collected on a beam trailer, without the mattress boards on either side being installed, which gave the space for the wheel to pivot.

By installing these mattress boards, the width across the trailer is increased, limiting the space for movement of the wheel if this were to pivot. The use of low loader trailers would have a similar limiting effect, protecting anyone working in the wheel arches from being trapped.
