# Bulk Tipper Trailer Ram Failure

**LIME & SLAG PLANTS**

**INCIDENT No:** 01473

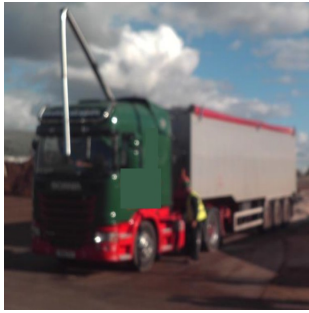
Whilst a load was being discharged from a bulk tipper onto a storage pad, the top ram mounting bolts failed. This resulted in the unsupported trailer body falling approximately 15 metres onto the chassis and the tipping ram striking the top of tractor unit cab.

Final Ram Position

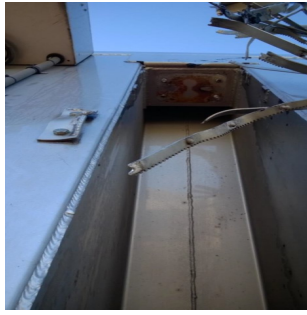
**Top of Tipper Ram Mounting Plate**

Ensure that any inspection and maintenance regime, takes into account other critical components that are not part of a mandatory VOSA inspection regime; in this case, the ram top mounting fasteners.
