INCIDENT ALERT

ALERT STATUS: Normal
DATE ISSUED: 19/12/2017 18:30:26
INCIDENT No: 01478

Fall from height into water - BMAPA Alert

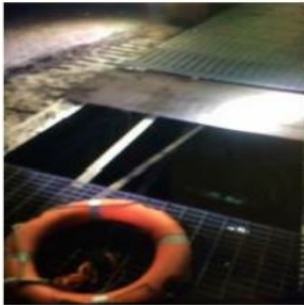
Upon leaving the crane, the deck hand stood on a section of walkway grid on the quayside that had worked loose due to vibrations from the crane. The grid had moved forward and was unsupported on its rear edge so when the IP stood on the unsupported side of the walkway, it pivoted on the central supporting beam resulting in both the individual and the grid falling into the river.

Missing grate

The IP stands on unsecure metal walkway grating that pivots, resulting in the person and grate falling into the water.

- Lack of inspection and maintenance of walkway gratings
- Gratings overlapping with the path of the tracked excavator
- Absence of physically marked exclusion zone
- Control of sub contractors (ships crew).

- Enforce prohibitive area by including in new pre-discharge procedure and establishing physical demarcation.
- Only named, authorised personnel to be permitted in the prohibited area
- Fix walk way grids so they can't vibrate loose
- Record inspections of walkways as part of pre-discharge procedure
- All personnel to wear life jackets
- Improved rescue equipment and man in water training for all staff.

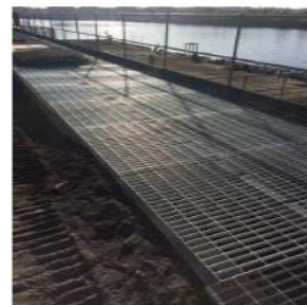
Grating secured - note overlap
