INCIDENT ALERT

LOCATION: READYMIX OR MORTAR PLANT
ACTIVITY: TRAFFIC MANAGEMENT
SUB ACTIVITY: ON-HIGHWAY

ALERT STATUS: High Potential
DATE ISSUED: 04/06/2018 15:29:23
INCIDENT No: 01491

Front End Loader in water pit incident

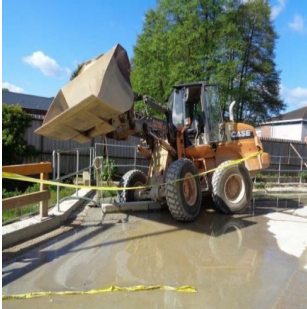
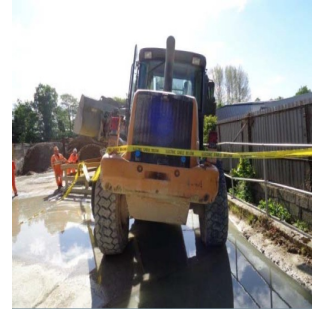
A front end loading shovel (FEL), entered a small water pit when the operator drove over a storm drain cover. This pit was situated along one edge of the yard and was adjoining a storm drain that connects to a nearby stream. The weight of the FEL caused the drain cover to collapse which in-turn caused the FEL to lean at a dangerous angle, presenting the potential of it tipping over.

- Limited all-round visibility – operator failed to see the drain cover under surface water
- Lack of adequate edge protection around water pit
- FEL fitted with standard vision mirrors only - wide angle convex mirrors should have been installed as well
- Contracted operator did not possess MPQC card or evidence of competencies concerning the operation of a FEL.

Following the incident on site, the FEL was turned off and the operator evacuated. The area was cordoned off to stop any entry and the machine was removed by a hired in heavy recovery truck. The driver was debriefed about the incident and completed a drugs and alcohol check.

- Edge protection around water pit to be improved FEL to be fitted with wide angle convex mirrors as well as standard vision mirrors
- An All Round Vision Assessment will be completed.
- Remind operators to never enter flooded areas unless they know what is beneath the surface
- Checks to ensure that all operators have undergone the required training and possess recognised competencies such as MPQC.
