# Front End Loader in water pit incident

**ALERT STATUS:** High Potential  
**DATE ISSUED:** 04/06/2018 15:29:23  
**INCIDENT No:** 01491

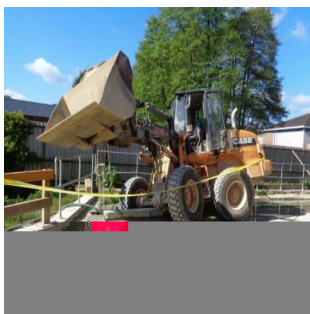
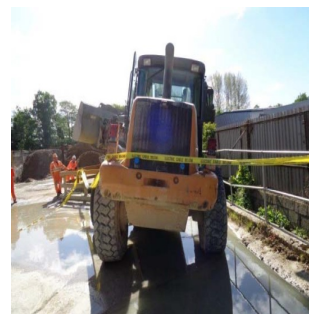
A front end loading shovel (FEL), entered a small water pit when the operator drove over a storm drain cover. This pit was situated along one edge of the yard and was adjoining a storm drain that connects to a nearby stream. The weight of the FEL caused the drain cover to collapse which in-turn caused the FEL to lean at a dangerous angle, presenting the potential of it tipping over.

- Limited all-round visibility – operator failed to see the drain cover under surface water
- Lack of adequate edge protection around water pit
- FEL fitted with standard vision mirrors only - wide angle convex mirrors should have been installed as well
- Contracted operator did not possess MPQC card or evidence of competencies concerning the operation of a FEL.

- Edge protection around water pit to be improved FEL to be fitted with wide angle convex mirrors as well as standard vision mirrors
- An All Round Vision Assessment will be completed.
- Remind operators to never enter flooded areas unless they know what is beneath the surface
- Checks to ensure that all operators have undergone the required training and possess recognised competencies such as MPQC.
