INCIDENT ALERT

LOCATION: CONCRETE PRODUCTS PLANT
ACTIVITY: PRODUCTION AND PROCESSING
SUB ACTIVITY: CONCRETE PRODUCTS

ALERT STATUS: Normal
DATE ISSUED: 10/01/2019 11:49:31
INCIDENT No: 01502

Stressed 12.5 mm. strand slipping - Use and maintenance of barrels and wedges

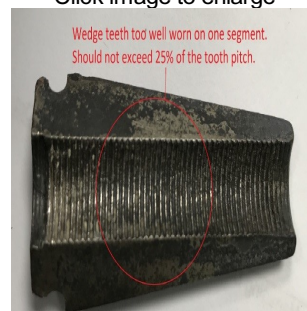
Figure 2

After sending the barrel and wedge which were involved in this incident for inspection, it was found that the teeth on the wedge had become flattened (see Figure 1).

Whilst the set, in question, had been visually inspected for cracks and broken teeth prior to use, the flattening of the teeth which ultimately caused the strand to slip had not been identified (see Figure 2).

- When inspecting the barrels and wedges it must be done in good light, with the aid of a magnifying glass.
- Wire brushes must be used to remove any dirt from the barrels and wedges when cleaning.
- All barrels and wedges must be thoroughly cleaned, examined and lubricated after each use.
- Ensure the site-specific safe system of work procedure for the cleaning of barrels and wedges is followed and the operative doing so is trained and competent in this procedure.
- Any barrels or wedges that are damaged or not fit for use **MUST** be discarded immediately.
- The daily inspection sheet which is completed after each inspection must contain the number of wedges inspected and the number discarded.

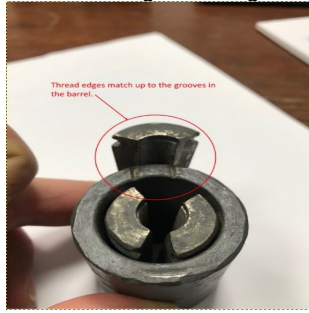
Figure 3

In addition to this only two of the segments of the wedge were in the barrel when stressing took place. When the barrel and wedge were on the loose strand the wedge worked itself away from the barrel and stayed on the strand due to the 'O' ring. As the jack has been pushed up to the grip one wedge segment went to the outside of the barrel with only two segments taking up the load on the strand. The two marks on the tapered side of the barrel indicate where the stressing nose was pressing the wedge teeth into the barrel, leaving the marks (see Figure 3).

Two segments have been known to hold a strand in place. Unfortunately, on this occasion they did not. It can only be put down to human error in ensuring the whole wedge is inside the barrel, which is something that can happen to the most reliable of stressing operators in certain situations.
