INCIDENT ALERT

LOCATION: QUARRY
ACTIVITY: MAINTENANCE & HOUSEKEEPING
SUB ACTIVITY: N/A

ALERT STATUS: Normal
DATE ISSUED: 28/05/2019 12:02:48
INCIDENT No: 01512

Fatal 6 - Return roller nip guard on conveyor falls 4m and hits contractor

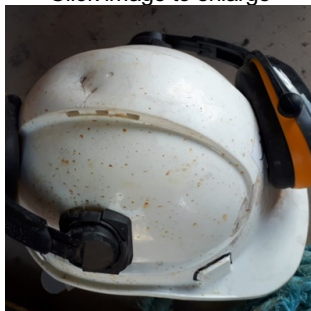
The guard weighing circa 8kg fell 4m and hit the contractor on the centre of his hard hat. Fortunately, the contractor suffered only neck and muscle strain and was able to continue working after a short period.

Hard hat with dent along back near centre

- Check to see if this type of system is present on your site
- If they are on site, amend risk assessments / safe systems of work to include the need to check how roller nip guards, rollers and scrapers are secured
- Ensure all return roller nip guards, rollers and scrapers are securely fixed before any conveyor belt replacement work commences
- Any person carrying out a task where objects or items above them could fall should wear a hard hat, not a bump hat.
- Exclusion zones should be set up in any area where equipment is being worked on overhead

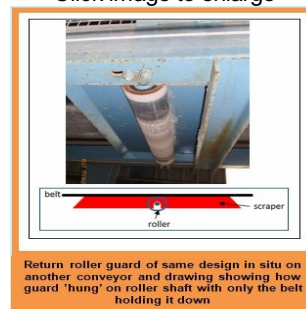
The contractor was standing under the incline conveyor belt system as he pulled the old conveyor belt through the system. During this operation an original return roller nip guard was dislodged. Investigation showed that it was designed so that it hung over the roller shaft and was only held in place by the belt and gravity.

Return roller guard of same design in situ on another conveyor and drawing showing how guard 'hung' on roller shaft with only the belt holding it down
