INCIDENT ALERT

LOCATION: READYMIX OR MORTAR PLANT
ACTIVITY: PRODUCTION AND PROCESSING
SUB ACTIVITY: READYMIX

ALERT STATUS: Normal
DATE ISSUED: 10/06/2019 13:07:08
INCIDENT No: 01513

Fatal 6 - Skip wire rope failure

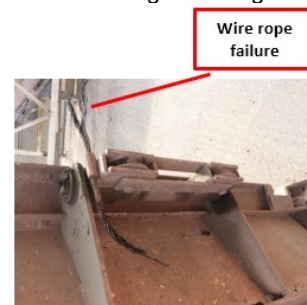
During the 4th cycle of a concrete batch, the Plant Manager (batching remotely) heard an impact across the yard in the vicinity of the aggregate skip hoist system. After accounting for all persons on site, the Plant Manager investigated and found the wire rope supporting the aggregate skip had failed, resulting in a loaded skip falling back down its track and breaking through a guard at the bottom. The area behind the guard is not a walkway but is an area where there is pedestrian access.

- The wire rope had not been inspected or replaced in the previous 18 months.
- Readymix standard for wire rope inspection is every 6 months with replacement at 12 months or 30,000m³; whichever occurs first.
- After replacing the skip rope, it was noted that the jerky movement that was there from the plant commissioning stage had disappeared. The jerky movement is likely to have placed increased stress on the wire rope behind the skip pulley mechanism.
- A relay switch and brake adjustment were both found to be outside of manufacturer's guidance.

- Recognising the warning signs and taking action.
- Ensure appropriate frequency of skip rope inspection, adjustment and replacement.
- Ensure inspection requirements are clear and that they are carried out by competent persons.
- Ensure relays / soft starts are operating correctly to manufactures guidelines.
- Consider potential line of fire of pedestrianised areas
