# Fatal 6 - Seaman struck by mooring line

BMAPA have issued the following alert outlining how a seaman was injured and the actions that have been recommended to improve mooring procedures following this incident.

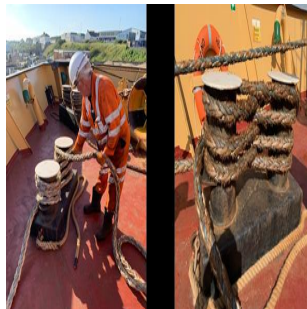
The vessel continued to move ahead slightly; placing strain on the secured mooring line. The mooring line surged (slipped) on the mooring bitts; the standing (unloaded) part of the line whipped from the deck, striking the Seaman in the groin.

- The mooring equipment in the vessel is undersized by contemporary standards for the rope size in use.
- Mooring equipment standards have been formalised/ amended several time since the vessel was constructed.

- The layout of mooring equipment in the vessel precluded use of best operational practice for use in service.
- Standard induction procedures were followed; however, could have been improved with more focus on ship specific issues.

- Co-ordination of communications and actions of the Bridge Team and instructions given to Deck Crew could be improved.
- Minor proportionate modification to Deck mooring equipment would be beneficial to eliminate an identified deficiency.

- There was no specific mooring plan in place for the task.

- The bridge team should review co-ordination between the timing of instructions given to deck crew and actions executed to control and manage the vessel; to ensure Deck Crew are not subjected to risk during mooring ops.

- The provision of induction refresher training to crew members established in the vessel should be considered.
- A task specific mooring plan should be developed to address the operation of securing the vessel during passage through Locks.

- On-board mooring practice while transiting Locks should be reviewed to determine whether operation of one mooring line at a time would improve safety without compromising other aspects of safe ship operation.

- A study to evaluate modification of the mooring bitts involved in this incident should be undertaken to determine whether a deficiency in layout can be eliminated.
