INCIDENT ALERT

LOCATION:	AGGREGATE DREDGER	ALERT STATUS:	Normal
ACTIVITY:	MARINE OPERATIONS	DATE ISSUED:	01/10/2019 11:34:09
SUB ACTIVITY:	SHIP TO SHORE	INCIDENT No:	01528

Fatal 6 - Seaman struck by mooring line

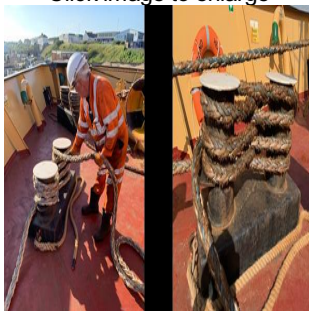
The vessel continued to move ahead slightly; placing strain on the secured mooring line. The mooring line surged (slipped) on the mooring bitts; the standing (unloaded) part of the line whipped from the deck, striking the Seaman in the groin.

- The mooring equipment in the vessel is undersized by contemporary standards for the rope size in use.
- Mooring equipment standards have been formalised/ amended several time since the vessel was constructed.

- The layout of mooring equipment in the vessel precluded use of best operational practice for use in service.
- Standard induction procedures were followed; however, could have been improved with more focus on ship specific issues.

- A study to evaluate modification of the mooring bits involved in this incident should be undertaken to determine whether a deficiency in layout can be eliminated.
