## INCIDENT ALERT

LOCATION:	QUARRY	ALERT STATUS:	Normal
ACTIVITY:	MAINTENANCE & HOUSEKEEPING	DATE ISSUED:	25/11/2019 09:36:43
SUB ACTIVITY:	N/A	INCIDENT No:	01535

Fatal 6 - Conveyor LTI - Laceration to arm

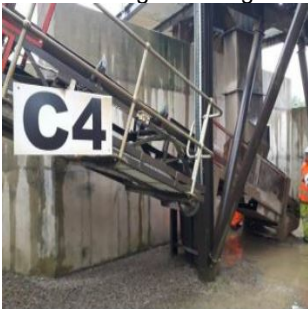
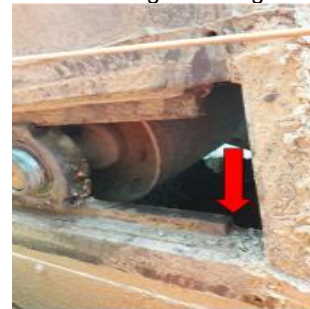
After lunch the injured party (IP) had time to continue the spillage clearance. The IP isolated the conveyor and the conveyor anti-run back initiated before removing the guard around the tail drum allowing access to the tail drum. He then proceeded to clear the material with a bar and his hand from between the bottom of the tail drum and the conveyor. The conveyor belt suddenly moved forward (uphill) as the last remaining spillage was cleared nipping the IP's hand between the bottom of the tail drum and the return belt. The return belt had to be cut to release the IP's hand who received a cut to the elbow area of the right arm requiring surgery to clean and stitch.

- No risk assessment undertaken
- IP eagerness to start the task

- No Formal SWP in place
- Failure to wear the correct PPE – Although this would not have prevented the incident, the POL agreed the severity of the Injury would have been reduced

It was agreed to produce a training document to highlight all risks (including all types of stored energy)

**PPE:** Correct use for different situations (Produce CREW training to demonstrate why we need to use and the consequences of not using correctly)
