# Fatal 6 - Conveyor LTI - Laceration to arm

LOCATION:	QUARRY	ALERT STATUS:	Normal
ACTIVITY:	MAINTENANCE & HOUSEKEEPING	DATE ISSUED:	25/11/2019 09:36:43
SUB ACTIVITY:	N/A	INCIDENT No:	01535

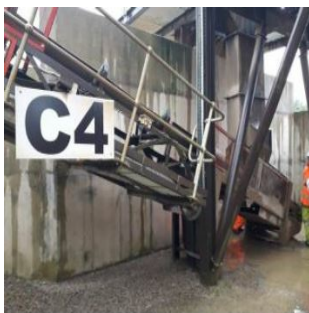
After lunch the injured party (IP) had time to continue the spillage clearance. The IP isolated the conveyor and the conveyor anti-run back initiated before removing the guard around the tail drum allowing access to the tail drum. He then proceeded to clear the material with a bar and his hand from between the bottom of the tail drum and the conveyor. The conveyor belt suddenly moved forward (uphill) as the last remaining spillage was cleared nipping the IP's hand between the bottom of the tail drum and the return belt. The return belt had to be cut to release the IP's hand who received a cut to the elbow area of the right arm requiring surgery to clean and stitch.

The Panel of Learning agreed the following Root causes

- No risk assessment undertaken
- IP eagerness to start the task

- No Formal SWP in place
- Failure to wear the correct PPE – Although this would not have prevented the incident, the POL agreed the severity of the Injury would have been reduced

It was agreed to produce a training document to highlight all risks (including all types of stored energy)

**PPE:** Correct use for different situations (Produce CREW training to demonstrate why we need to use and the consequences of not using correctly)
