INCIDENT ALERT

LOCATION: CONSTRUCTION/DELIVERY SITE
ACTIVITY: TRANSPORT / DELIVERY
SUB ACTIVITY: PRODUCT DELIVERY

ALERT STATUS: Normal
DATE ISSUED: 11/12/2019 09:30:37
INCIDENT No: 01539

Hydraulic Tipper Door Injury

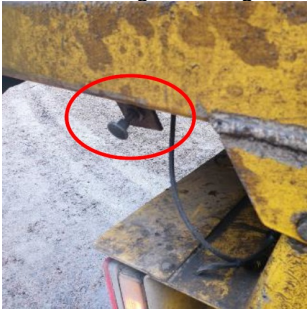
Air Ram Release Button

A tipper truck was reversing on site to tip and was being guided by the site banksman who was part of a contractors site staff. The banksman had stopped the truck, and whilst the driver was engaging the PTO for raising the body of the truck, the banksman took it upon himself to push the button to operate the air rams for the split half door.

All drivers should be aware of their responsibilities when carrying out tipping operations.

Banksmen are NOT to touch any part of a vehicle or plant unless instructed to do so by the driver, or as part of their normal duties.

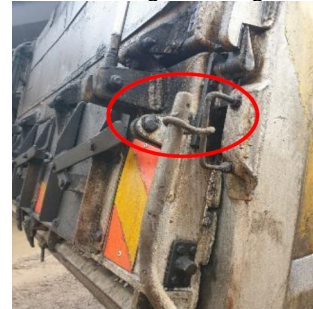
Door Handle Retaining Ring

Due to the retaining rings which hold the doors closed not being released before the air ram button was pressed, this put pressure on the door release handles. When the driver came to release the handles by lifting the rings, the split door opened under pressure and hit him on the side of his upper body near his ribs, causing significant bruising.

The driver of the truck is the only person who should operate the system for releasing the back door - the banksman should not have touched the truck unless directed to by the driver.
