Fatal 6 - Ship's crew struck by falling hose

LOCATION:	AGGREGATE DREDGER	ALERT STATUS:	Normal
ACTIVITY:	CONTRACTOR SAFETY MANAGEMENT	DATE ISSUED:	17/12/2019 17:04:16
SUB ACTIVITY:	MARINE	INCIDENT No:	01541

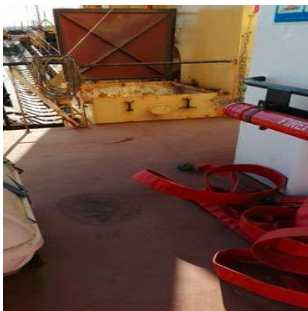
A UK marine aggregate dredger was in the final stages of a refit at a UK shipyard. During the refit, the ship had been supplied with fresh water through a shipyard hose. Shipyard workers were recovering the hose after it had been disconnected by a crew member, who had connected two sections of hose together.

Site of hose recovery

- Interaction between crew and contractors must be planned; to properly understand the task and apply necessary control measures.
- An appropriate level of assessment must be used for all tasks; including those perceived as low risk or minor.
- First-Aid/ medical treatment must be provided; however, duties must be assigned to ensure an incident scene is preserved; and evidence secured for investigation.
- Compliance with prescribed PPE requirements is mandatory; requirements must be clear to employees and not subject to interpretation.

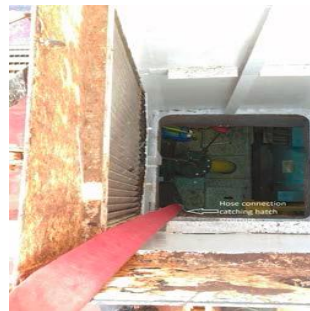
As the hose was hauled up by hand through a hatch, the bayonet connection between the two hose sections caught on the coaming; resulting in the two sections separating. The lower section dropped through the hatch; and, despite a shouted warning, struck the crew member on the forehead; requiring hospital attendance to close the wound.

- Beyond disconnecting the hose, crew members were assisting shipyard staff with a task, with which they did not need assistance
- Interaction between ship and shore personnel was not planned, assessed or coordinated
- The crew member failed to properly connect the hose sections together
- Whilst medical treatment was provided to the IP, the opportunity to preserve the scene and secure evidence was lost
- Adequate PPE was not being worn.

Hatch through which hose was being recovered
